SCAMMON BAY HEALTH CLINIC

Alaska Rural Primary Care Facility Code and Condition Survey

Final
July 23, 2001

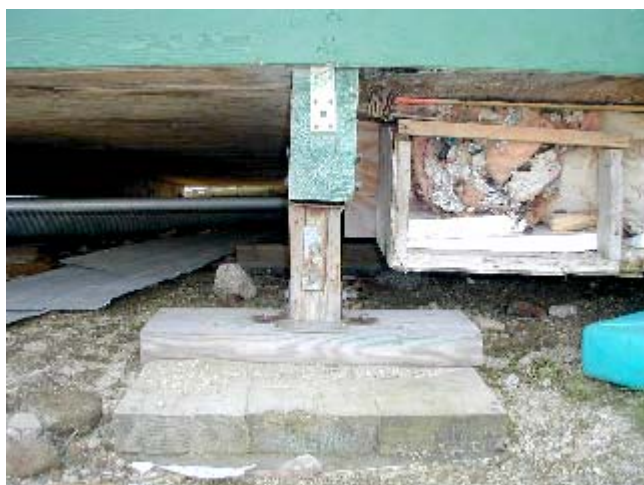
The floor is 2 x 12 joist over a 2 x 12 floor beams. The beams are supported with 6 x 6 posts with 3 x 12 pads under the posts. There is R-19 insulation in the floor with 3/8" plywood on the bottom of the joist. . There is extremely abnormal amount of building shifting down hill with some settlement and heaving that has caused doors to stick and floor to be uneven. There is approximately 11 inches of differential in the floor elevations. Some piping has been relocated internal to the room space and utilidors are in very poor shape causing major freezing problems with the facility.

Structure shifting and utilidor poor

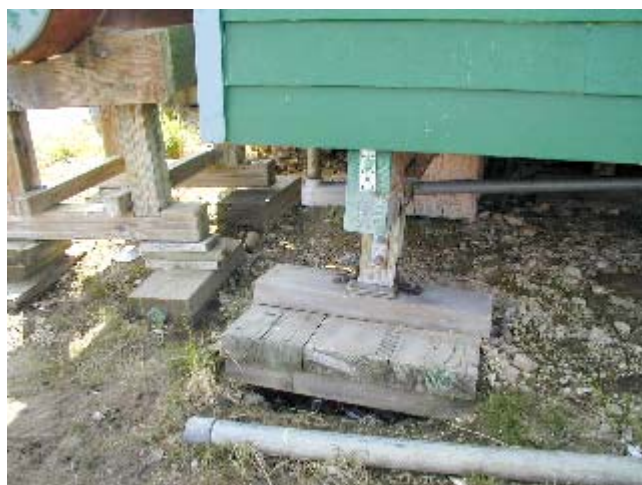
The foundation is treated 6 x 6 posts on 3 x 12 pads for support. Pads have settled substantially, walls are racked, and the building has floor level deviation and has substantial cracking on the interior. There is no hold down strapping in some places due to removal to try and level the facility. The bracing is loose or missing. In general the foundation needs substantial upgrade work for a new useful lifetime or replacement.

Structure shifting and lifting pads

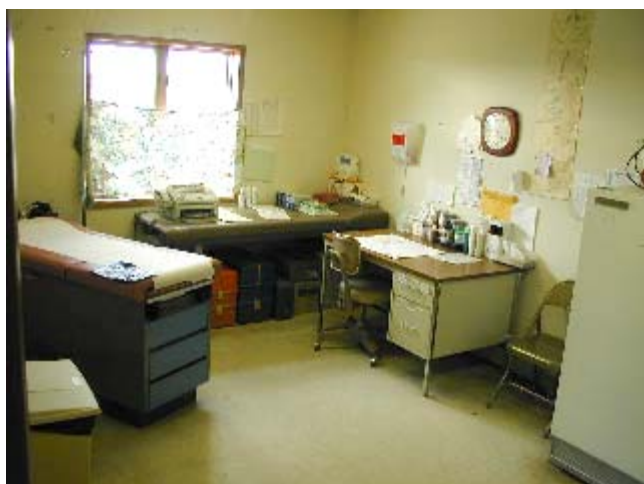
Trauma/Exam Room 1

- c. Exam / Trauma – There is one exam/trauma room available. The room though sized adequately is full of other clinic equipment and storage items. It is accessible for gurney with a large solid core door but does not have ADA hardware. Privacy is somewhat difficult since all the exam rooms open to the main waiting/circulation hall.

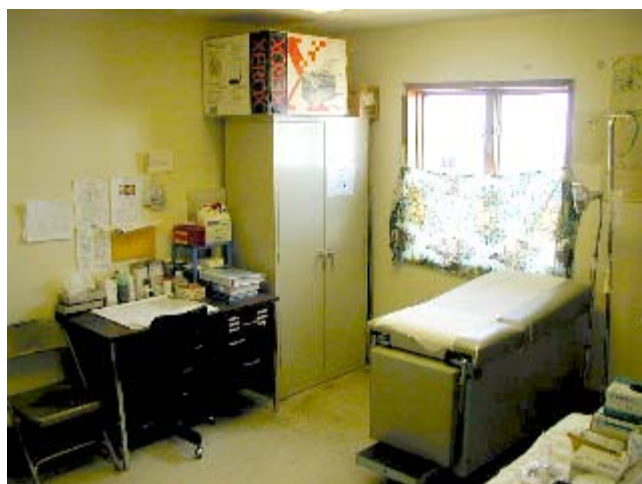
Exam Room 2

- d. Exam room – There is one smaller exam room with adequate space for normal operation. Like the trauma room the exam room has considerable additional storage of items due to the lack of storage in the facility. Additionally the sink is not to code and sanitary conditions. It has a plywood cabinet, and no ADA access.

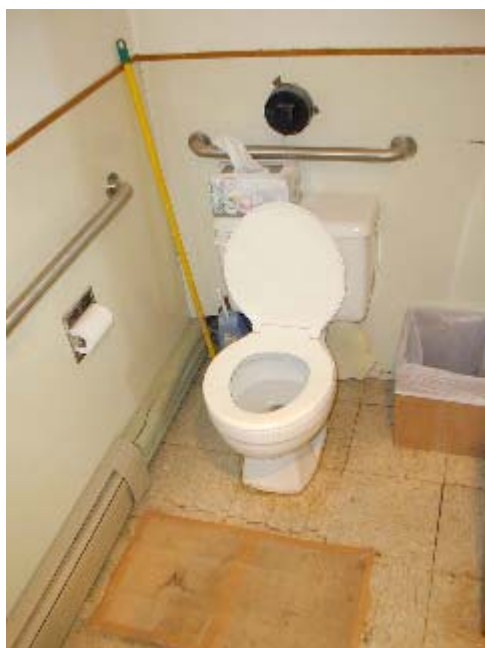
- j. HC Toilet Facilities – There are two toilet rooms, one serves patients and the other clinic staff. Neither toilet room meets any of the ADA or UPC requirements. The toilet and sink lacked sufficient clearances and were of incorrect fixture type. There is no vacuum breaker on this sink as required by code. There is no tub. All these areas are very unsanitary due to deteriorating floor system and wall joints from structural shifting.

Toilet and floor deterioration

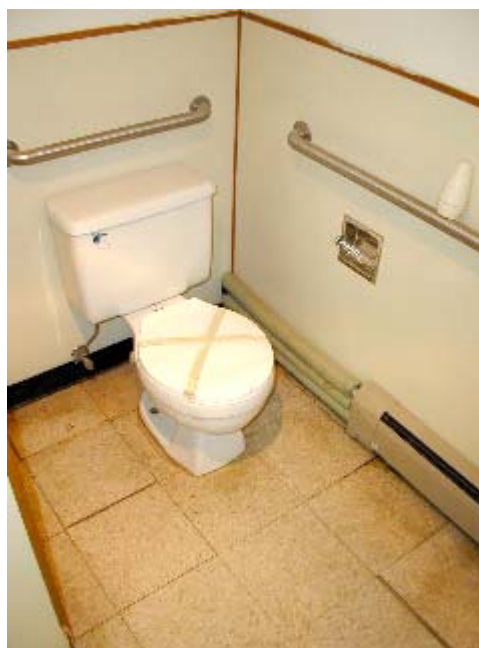
Second toilet deterioration

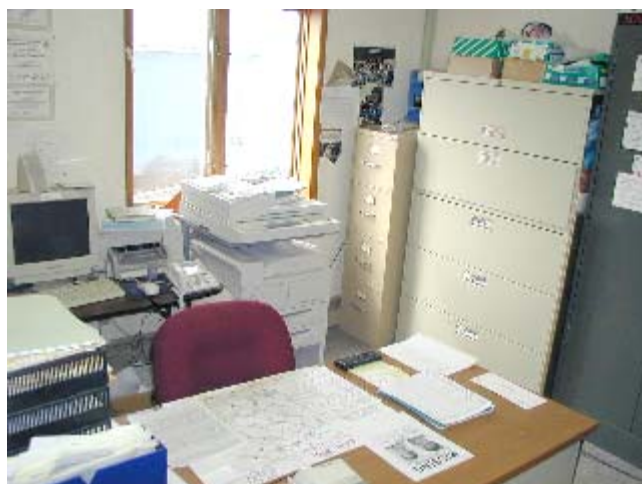
- e. Office / Administration / Records – This room has a two desks, copier, fax, a single patient chair, and considerable storage. There is a sliding glass window to the waiting room that does not provide adequate privacy for patient interviews and phone calls. This room is not large enough for an office and when a patient is also in the room it is very tight. The electrical service is totally inadequate for this room and the facility.

Office is quite small

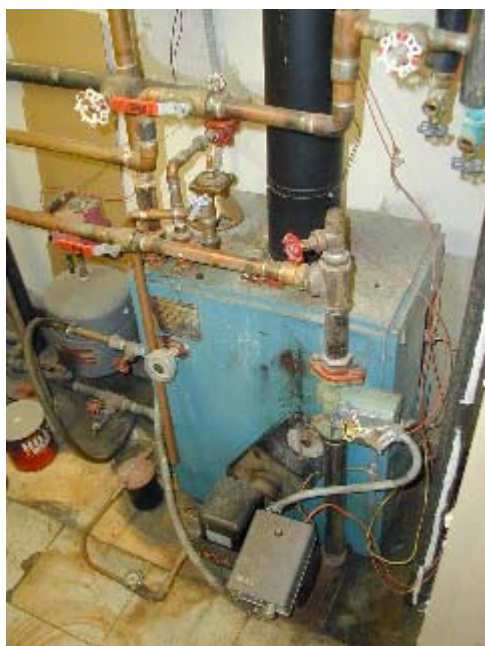
A single residential grade, oil-fired boiler provides heating for the entire clinic. The boiler is in poor shape with missing controls and systems to meet the needs of the Health Clinic. There is severe corrosion on the boiler stack and the vent assembly is in poor condition. There is one combustion air openings for the boiler. There are no additional heaters in the clinic to assist with heating. The boiler room is used for general clinic storage.

Boiler

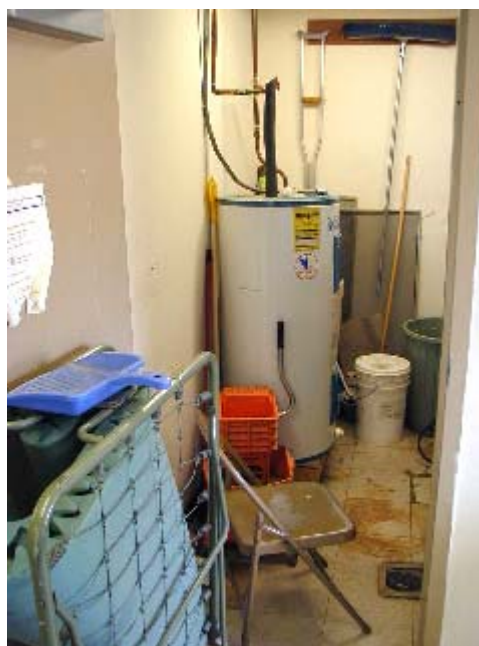
- k. Janitors Room – There is a room that has a janitor's sink that also is the boiler room, and other equipment items. It is very crowded.
- l. Mechanical/Boiler room – The Mechanical room or Boiler room is also the janitor room above and storage room. This is a very unsafe condition and does not meet code. There is no full 1 hr. separation due to hole in walls.

Boiler room / janitor / storage
